NATIONAL PROGRAM FOR INSPECTION OF NON-FEDERAL DAMS
BIRGE POND DAM (CT 00...10) CORPS OF ENGINEERS WALTHAM
MA NEW ENGLAND DIV JUL 80

BIRGE POND DAM
CT 00007

CONNECTICUT RIVER BASIN
BRISTOL, CONNECTICUT

PHASE I INSPECTION REPORT
NATIONAL DAM INSPECTION PROGRAM

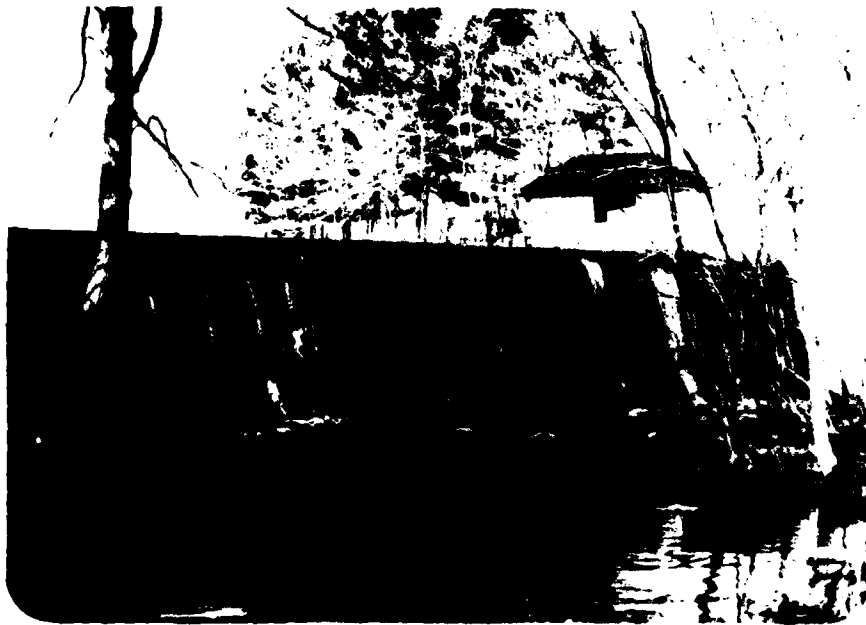
PHOTO NO. 4

SPILLWAY FROM DOWNSTREAM

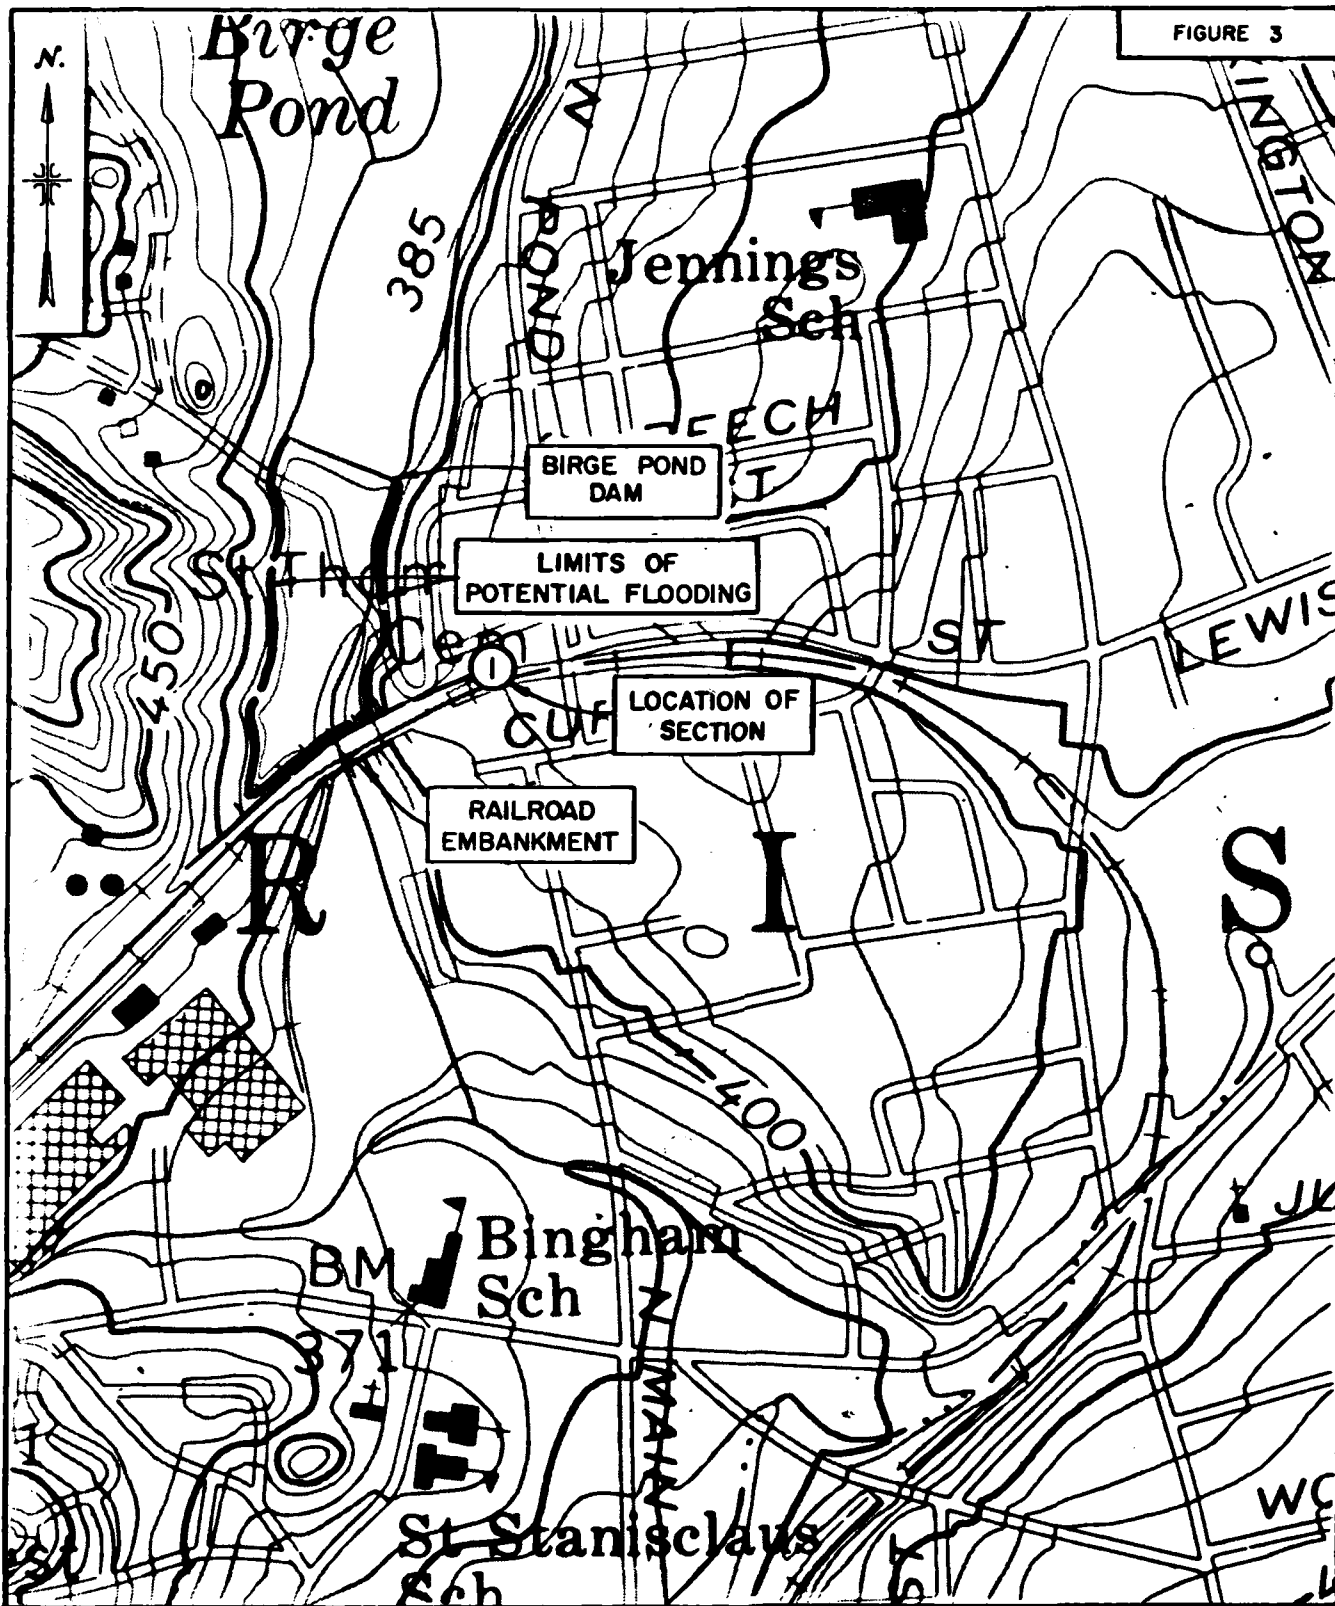
LIMITS OF POTENTIAL FLOODING

Downstream culverts have a capacity of 1080 cfs according to the Bristol City Engineer. The roadway approximately 200 feet downstream of the dam would be inundated by 15 feet of water and possibly washed out. It is doubtful the railroad embankment would be damaged as a result of the dam breach.

No homes are located within the potential limits of a dam breach flood, therefore, the loss of any lives is unlikely. The dam is classified as "Low" Hazard Potential in accordance with the Corps of Engineers' Recommended Guidelines for Safety Inspection of Dams.
